TECHNICAL SERVICE BULLETIN

4T65E 2006 AND LATER CHEVROLET "W" (IMPALA & MONTE CARLO) RPO# MN7 or M15

SHIFTER WILL NOT MOVE OUT OF PARK

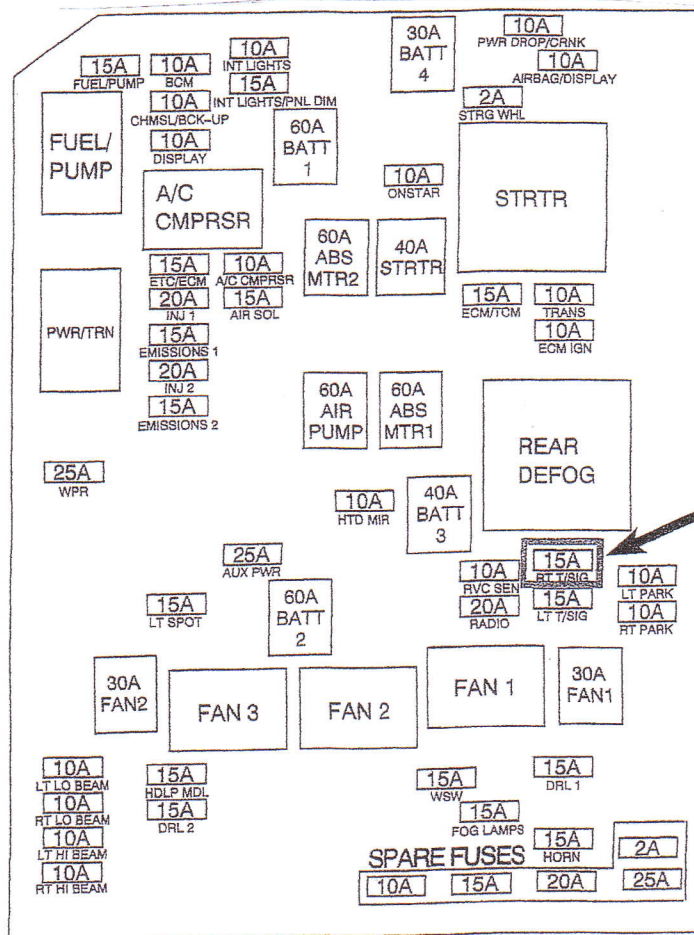
- Turn signal operation
(right rear turn lights are inoperable while the right front lights operate correctly).
 - Electric trunk switch will not operate.
 - **BTSI (Brake Shift Interlock Solenoid) does not allow transmission to be shifted from park.**
- Label of the fuses in this vehicle can lead to diagnostic issues for the above concerns. The 15 amp fuse labeled "RT" T/SIG located in the UBEC (Under-hood Bussed Electrical Center) will cause the problems described above if it is bad.

Replace the fuse if it is open.
